# MANHOLE INSPECTION REPORT

**MANHOLE NO.** G-325

**LOCATION** – Yard Area SE  
Endevour Hall. Bldg. 1559

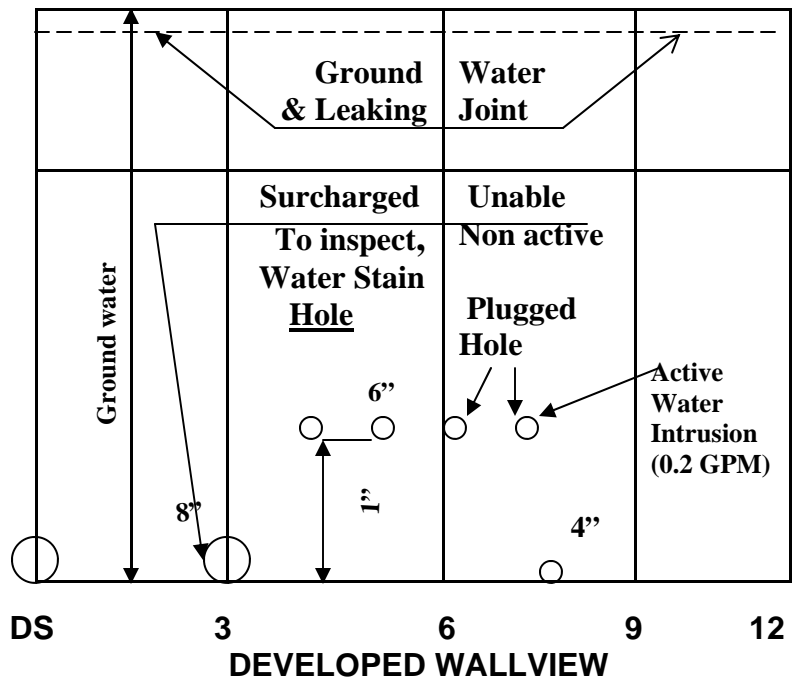
Good Condition (out)  
Fair Condition (in)  
Good Condition (in)  
Good Condition (in)

**SURCHARGE** – Yes

**FRAME TO CHIMNEY** - Grout Seal Fair Condition  
Deteriorated & Broken

**WALL** – Brick Construction  
Fair Condition  
Previously Rehabilitated

**BENCH** – Poured Concrete  
Good Condition  
Sludge Deposit

**INVERT** – Poured Concrete  
Good Condition  
Silt Deposit

**RECOMMENDED REPAIR PRIORITY**  
6.0
