# Last-Minute Repairs for Indians' Home Opener

But in addition to the weather, there was another variable affecting the success of the first Tribe game in Cleveland this year. Just across the street from Jacobs Field, a deteriorated 80-year-old, brick, sewer manhole servicing the stadium had collapsed on Feb. 8, creating a sinkhole in the intersection of Ontario and Eagle Avenues.

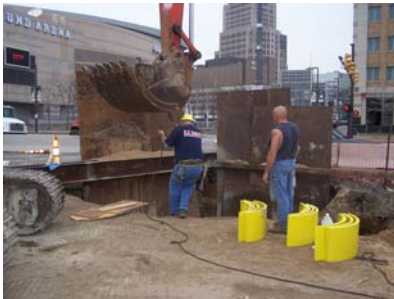
Although sewer flow through the manhole was never interrupted, the manhole collapse created a traffic issue by forcing the closure of two lanes on Ontario Avenue. The brick manway and the surrounding road surface, located directly across the street from Jacobs Field and the Cleveland Indian's administrative office, needed to be repaired before

Inland Waters Pollution Control Inc. (IWPC) based in Detroit, was given the assignment to fix the failed manhole and surrounding roadway. IWPC prepared a design that would allow repair of the damaged structure instead of a total replacement, an approach that would save both time and money, if it could be successfully implemented.

On April 3, Inland Waters and its manhole rehabilitation sub-contractor, Lee Infrastructure Restoration Inc., of nearby Solon, Ohio, began repairing the structure. Lee Infrastructure enlisted Spray Com Utilities Inc, of Sedalia, MO., a Permaform/Permacast Licensee, as their sub-contractor, to aid them in the repair of this project. Lee Infrastructure Restoration was contracted to install three, 20 ft. long, cured-in-place (CIP) liners to repair the three brick sewer lines that tie into the damaged manhole. The manway was then to be rebuilt using Permaform cast-in-place technology by Spray Com Utilities Inc.

When the work began, there was a 6-ft by 12-ft hole and the pipe had cracked and settled several inches, further compounding the repair. The crew from Spray Com Utilities Inc had to carefully winch the 20-ft long CIP point repair into place with out further damaging the sewer pipe.

liner in this damaged pipe was installed without incident and the main obstacle to this repair was past. Spray Com Utilities Inc then steam-cured the resin for four hours to form a pipe where no carrier pipe had existed.

Another minor problem was that the new CIP line didn’t completely seal into the egg-shaped design of the original host pipe. Spray Com Inc resolved that by pressure grouting the annular space, which also ensured that no air pockets were left in that pipe that might cause settling. After all three CIP liners had been installed, Spray Com Utilities Inc used Permaform technology to cast-in-place a new manhole

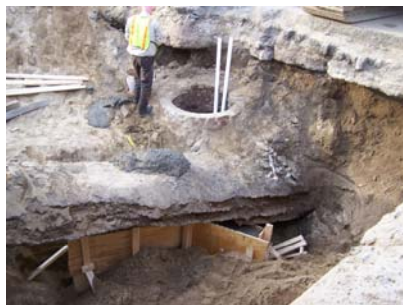
However, in the time necessary for the design approval process, the structure had continued to degrade. The hole in the lateral pipe had actually expanded by more than 200

percent since it was first discovered. Additional movement of the existing pipe had caused the pipe to drop even further from where it had initially cracked. Degradation of the exposed brick sewer pipe was primarily a function of the frost and thaw cycle encountered during the late winter months.

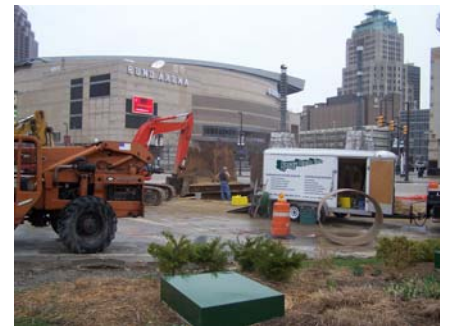
The main challenge was the repair of the 91-in. tall, egg-shaped, brick sewer lateral that ran from Jacobs Field to the

failed manhole. From the time the failure was first uncovered in early February 2005, the hole had expanded continuously.

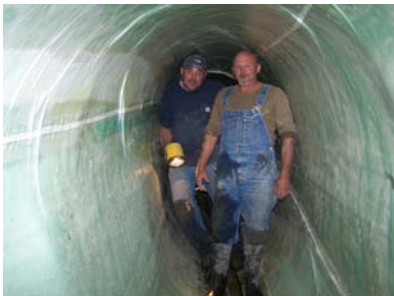
A further issue was the infiltration of the CIP liner to the required pressure of 4 psig. Spray Com Utilities Inc had to continuously monitor the remaining brick sewer to ensure the infiltration of the liner did not result in complete failure of the brick pipe. The
