Last-Minute Repairs for Indians' Home Opener

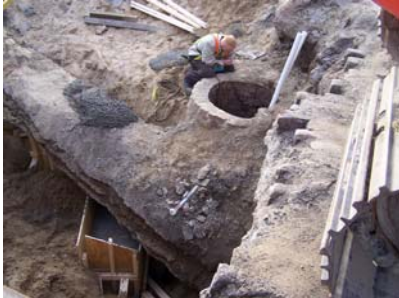
The main challenge was the repair of the 91-in. tall, egg-shaped, brick sewer lateral that ran from Jacobs Field to the

failed manhole. From the time the failure was first uncovered in early February 2005, the hole had expanded continuously.

When the work began, there was a 6-ft by 12-ft hole and the pipe had cracked and settled several inches, further compounding the repair. The crew from Spray Com Utilities Inc had to carefully winch the 20-ft long CIP point repair into place with out further damaging the sewer pipe.

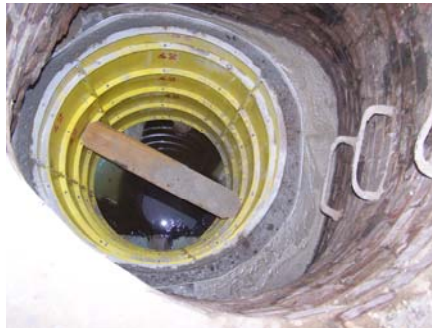
Another minor problem was that the new CIP line didn’t completely seal into the egg-shaped design of the original host pipe. Spray Com Inc resolved that by pressure grouting the annular space, which also ensured that no air pockets were left in that pipe that might cause settling. After all three CIP liners had been installed, Spray Com Utilities Inc used Permaform technology to cast-in-place a new manhole

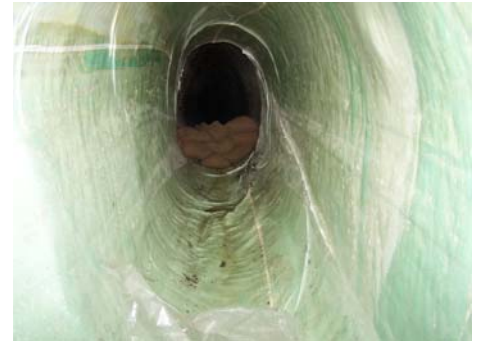
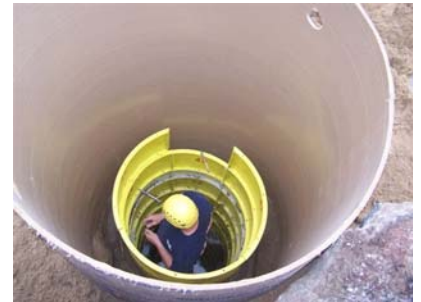
over the cured-in-place pipes to complete the rehabilitation of the manhole.
